Aztec Property Inspections
3655 Cowley Way
San Diego, CA 92117
(858) 245-9329

Client: James Goding

4039-4043 N. Bonita St
Spring Valley, CA 91977

James Goding
15-99

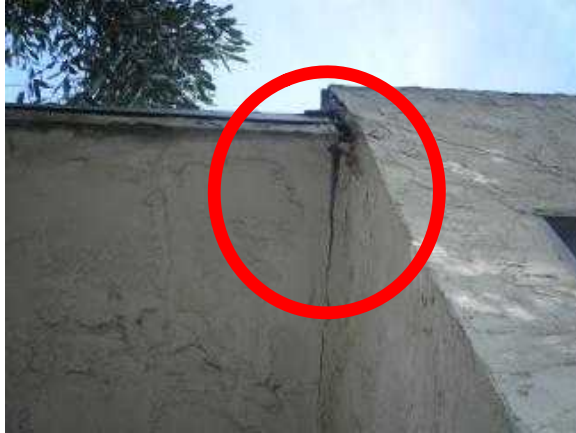
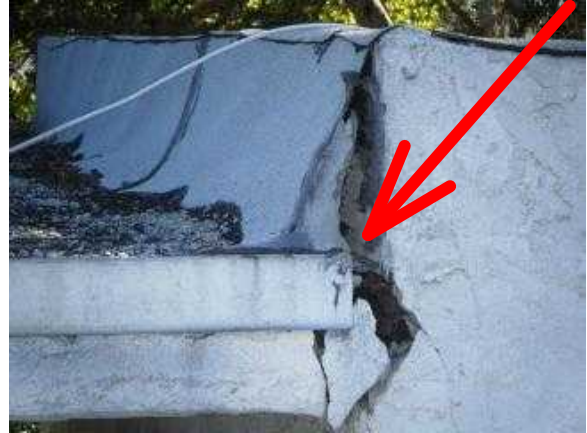
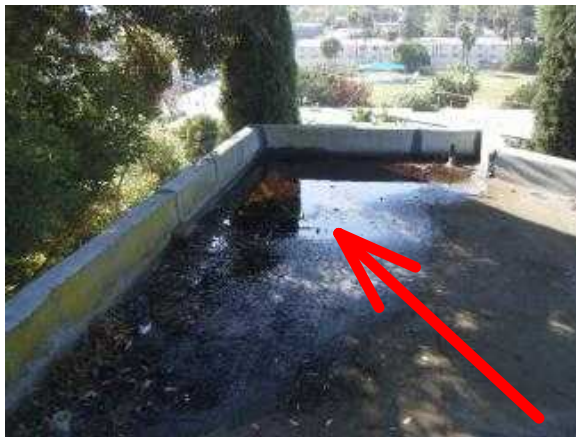
Material: (Rolled roof material) An overhang showed severe signs of cracking. Debris noted on roof. Removal is recommended. Moisture stains were noted on the ceiling. No leaks noted during the inspection. Roof was spongy to walk on. Evidence of significant sagging was noted to the ceiling of 4043 in this area (see 4043 interior rooms section). Loose material was noted in one or more areas. Worn and or weathered roofing material was noted at one or more areas. The roof could be nearing the end of it's life span. Significant signs of poor drainage noted. Standing water was noted in one or more areas. A qualified licensed contractor is recommended to evaluate and estimate repairs.

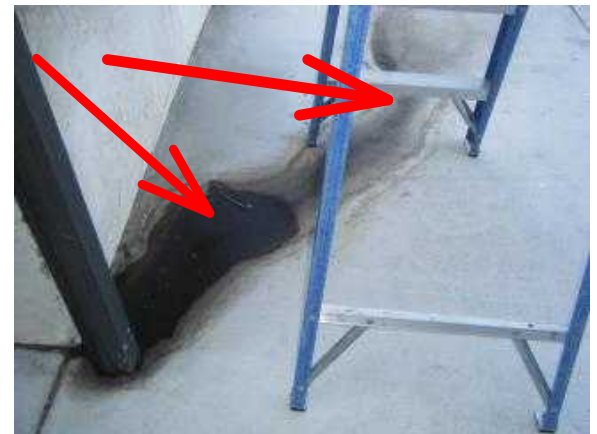
Downspouts: Paint deterioration noted.
Rout away in one or more areas.
Correction is recommended.

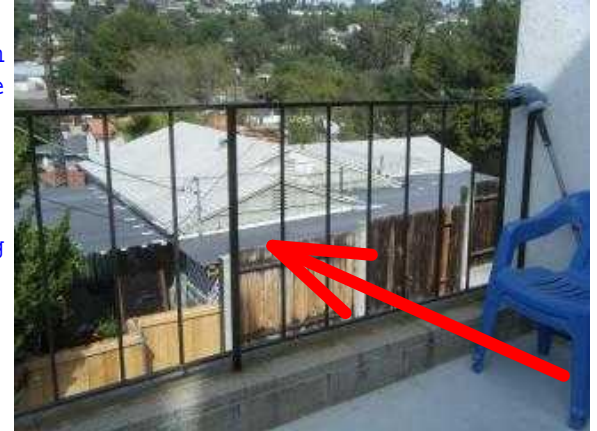
Walkways: Patch and repair was noted. Inquire with seller. Moderate to common cracks noted. Evidence of poor drainage in one or more areas. Slats of the guardrail and or handrail have gaps that are too wide based on the current standards. This is designed to protect infants and small children from falling through. Correction is recommended for added safety.

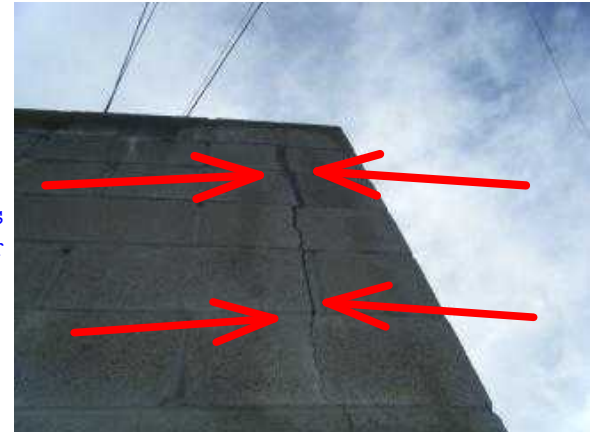
Retaining Walls: Cracks were noted. Caps on the wall were not secured in one or more areas. No surface drains or drainage openings were visible in one or more areas. This condition can lead to damage to the wall and eventually failure. Soil was coming over the walls in one or more areas. Recommend further evaluation and repairs as necessary by a qualified contractor.

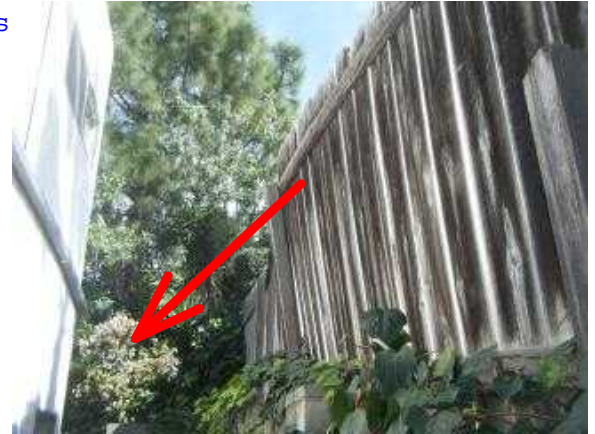
Fences: Loose and or leaning fencing was noted in one or more areas. Correction is recommended.

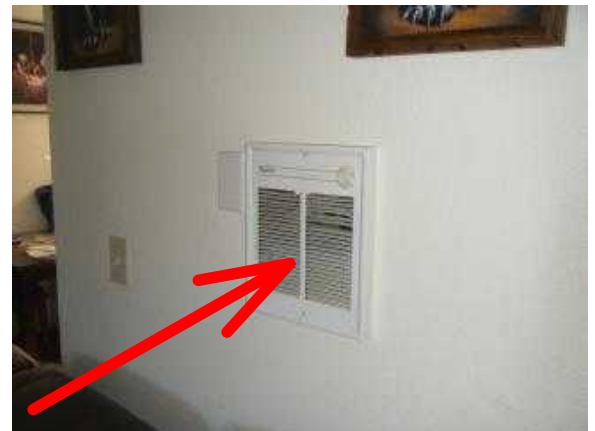
Operation: Upstairs heat was not operational. A qualified licensed contractor is recommended to evaluate and estimate repairs.

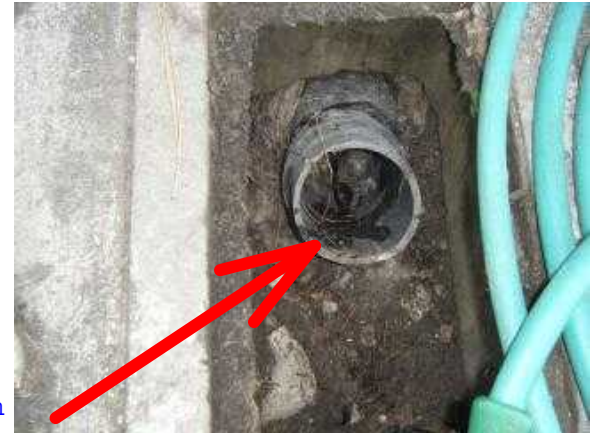
Waste Lines (ABS) Not fully visible. A clean out cover was missing in one or more areas. This could allow sewer gases to come up through the pipe and correction is recommended. Trees were noted in the yard. Damage caused by tree roots or future damage is beyond the scope of this inspection. We recommend having a qualified licensed professional come out and scope (run a camera in the waste lines). This is always recommended due to the cost of the "scoping" being minimal in relation to any needed repair work.

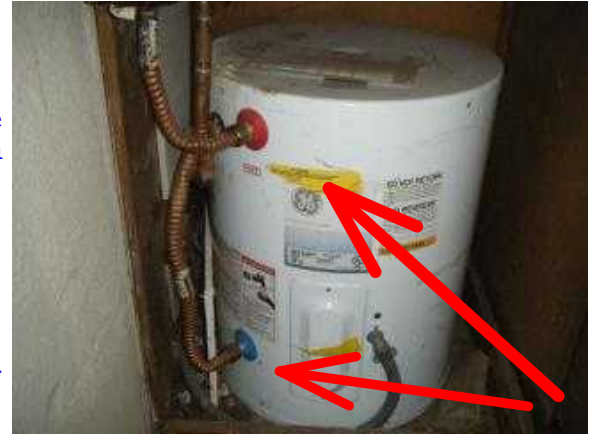
Seismic Straps: The water heater doesn't have proper seismic straps installed. This is a safety hazard since movement could cause leaks in the gas supply lines if the water heater is fueled by natural or propane gas, or could pose a shock and/or fire hazard if electric wiring is damaged or broken. Leaks may also occur in water supply pipes, which is a conducive condition for wood destroying insects and organisms due to accumulated water. A qualified contractor should install earthquake straps as per standard building practices.

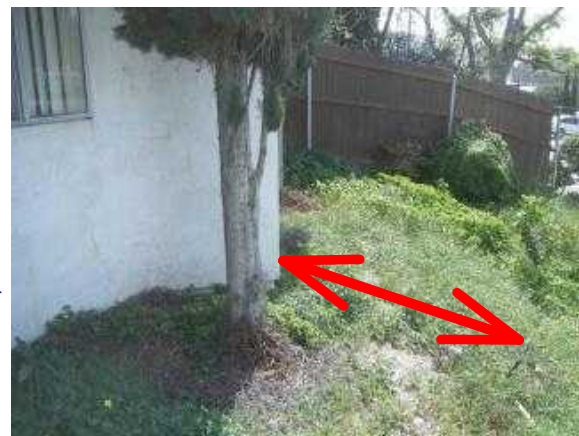
Floor/Slab: Slab was not visible due to carpet and/or floor covering but no readily visible problem was noted during the inspection. The exterior portion of the slab has been painted and or covered with stucco and was not fully visible. Unable to verify if the set back from the structure to the hill side was proper. The structure appeared to be unusually close to the hill side. If the soil is not determined to be stable, this may cause more than usual settling. Home inspectors are generalists and as so, it is beyond the expertise of the inspector to determine the significance of these items. The client may wish to consult with a civil engineer to determine the significance of these items.

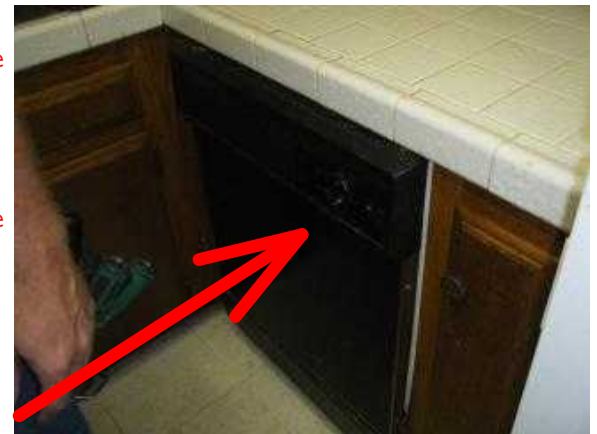
Acceptable **Cooking Appliances:** (Electric)
Acceptable **Cooktop** (Electric)
Acceptable **Ventilator:**
Acceptable **Disposal:**
Defective **Dishwasher:** Determining the adequacy of the washing and drying functions of the dishwasher is not a part of this inspection. The unit does not appear to be properly operational at the time of the inspection. A licensed plumber is recommended to evaluate and estimate repairs.

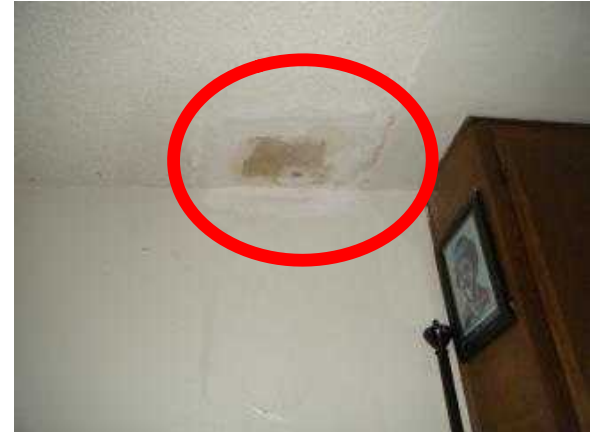
Ceiling: Damaged acoustic spray was noted in one or more areas. Testing the acoustic spray is highly recommended to see if it contains asbestos. Water stains present. Unable to locate an active leak. Inquire with the seller and/or a licensed professional. Water stains and damage were present in one or more areas. Active water intrusion was noted in one or more areas (dining room/below upper bathroom). A qualified licensed contractor is recommended to evaluate and estimate repairs.

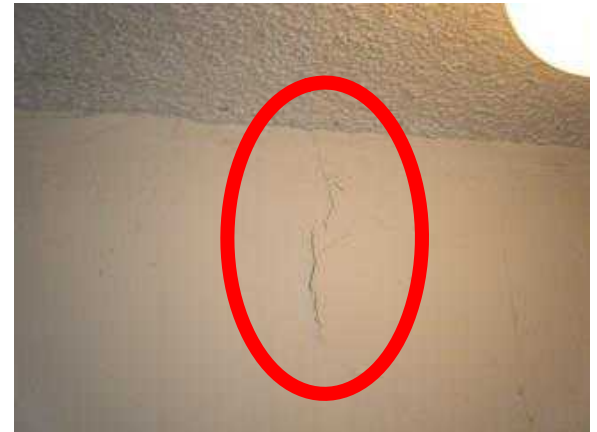
Walls: Paint deterioration was noted. Moderate to common cracks were present. Damage and deterioration noted in one or more areas. Correction is recommended.

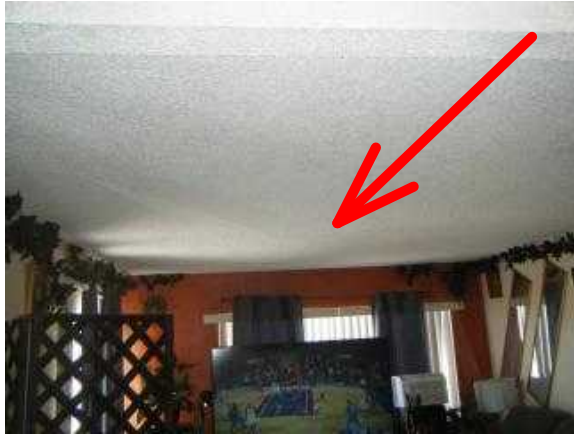
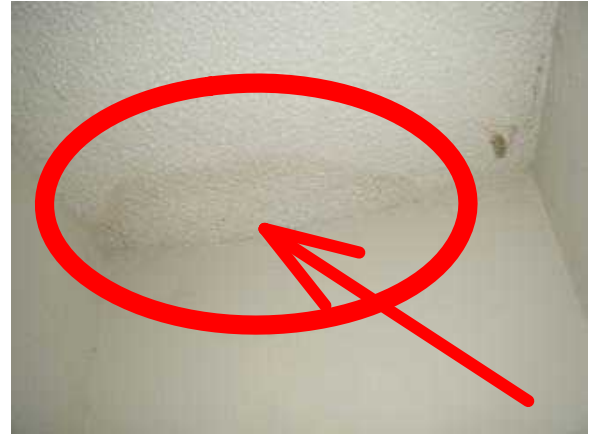
Ceiling: Damaged acoustic spray was noted in one or more areas. Testing the acoustic spray is highly recommended to see if it contains asbestos. Cracking noted in the hall. This appears to be where the upper enclosed patio is located. Water stains present. Unable to locate an active leak. Inquire with the seller and/or a licensed professional. Significant signs of sagging were noted to the ceiling (living room/1st bedroom closet). A qualified licensed contractor is recommended to evaluate and estimate repairs.

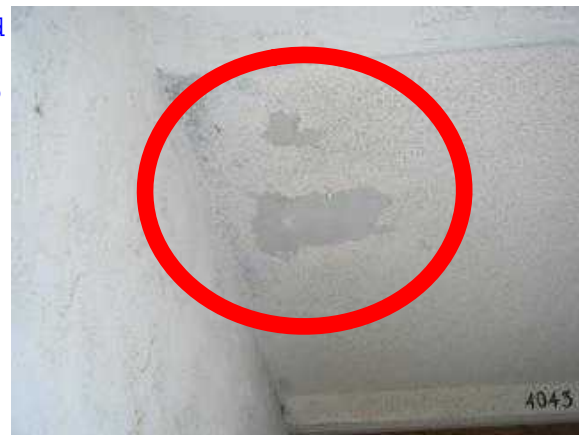
Ceiling: Damaged acoustic spray was noted in one or more areas. Testing the acoustic spray is highly recommended to see if it contains asbestos.

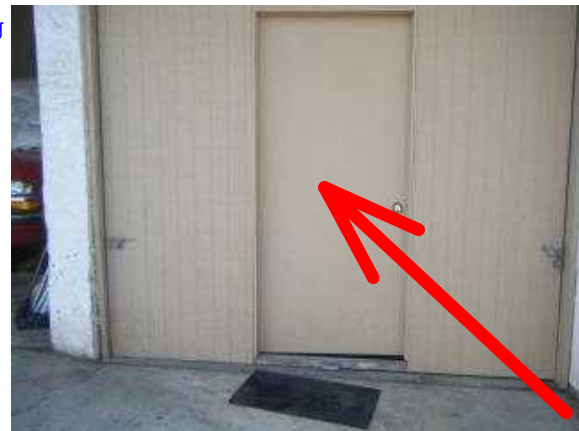
Note: Storage area not accessible during the inspection. Hidden problems may be present which are not included in this report.

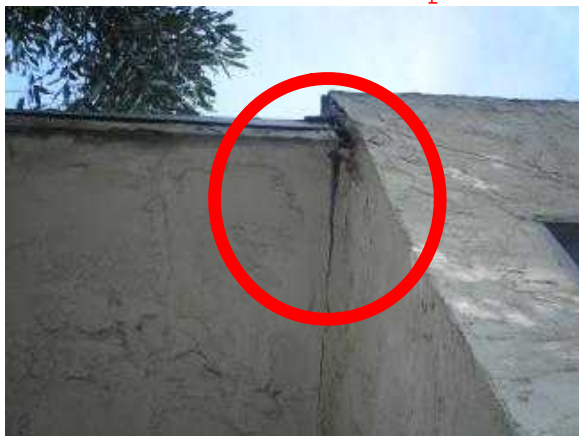
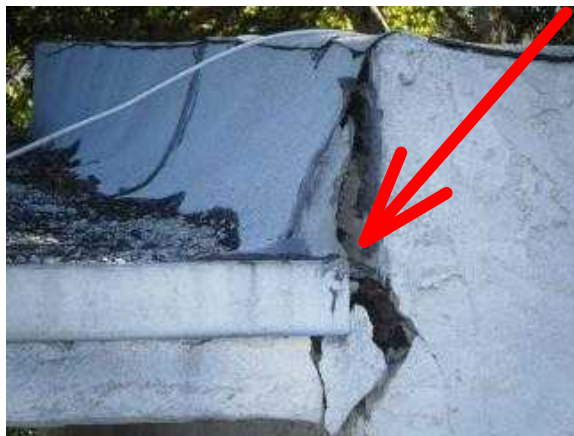
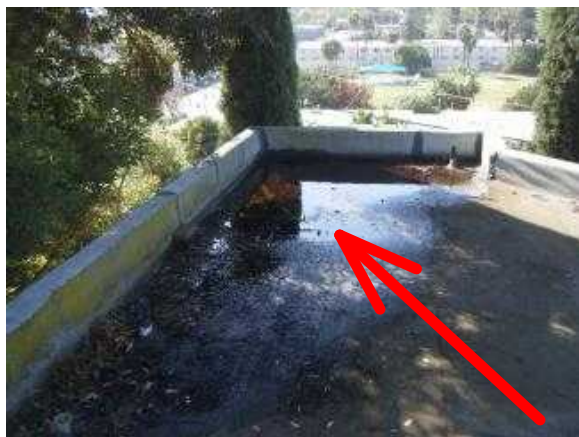
- Material:** (Rolled roof material) An overhang showed severe signs of cracking. Debris noted on roof. Removal is recommended. Moisture stains were noted on the ceiling. No leaks noted during the inspection. Roof was spongy to walk on. Evidence of significant sagging was noted to the ceiling of 4043 in this area (see 4043 interior rooms section). Loose material was noted in one or more areas. Worn and or weathered roofing material was noted at one or more areas. The roof could be nearing the end of it's life span. Significant signs of poor drainage noted. Standing water was noted in one or more areas. A qualified licensed contractor is recommended to evaluate and estimate repairs.

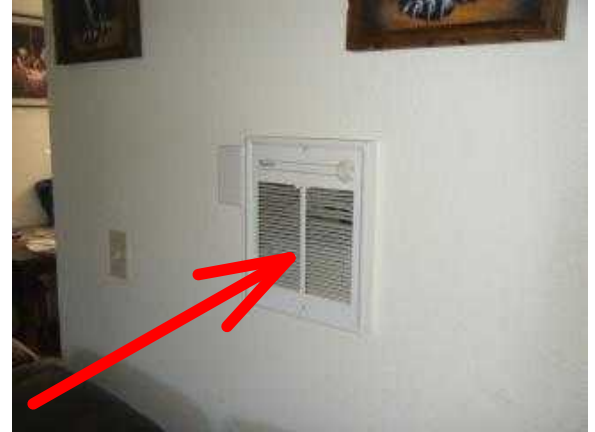
2. **4041 Heating System Operation:** Upstairs heat was not operational. A qualified licensed contractor is recommended to evaluate and estimate repairs.

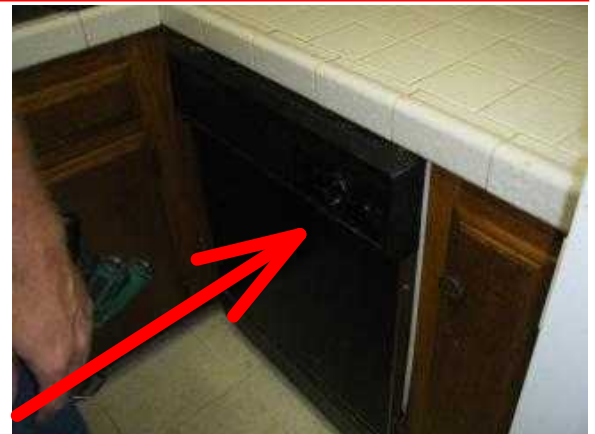
3. **4043 Kitchen Dishwasher:** Determining the adequacy of the washing and drying functions of the dishwasher is not a part of this inspection. The unit does not appear to be properly operational at the time of the inspection. A licensed plumber is recommended to evaluate and estimate repairs.

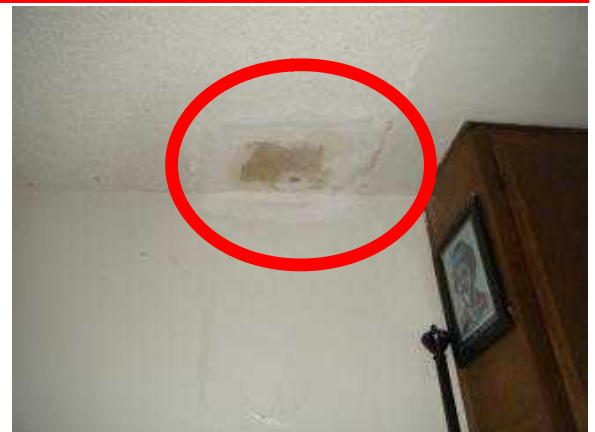
5. **4039 Living Space Ceiling:** Damaged acoustic spray was noted in one or more areas. Testing the acoustic spray is highly recommended to see if it contains asbestos. Water stains present. Unable to locate an active leak. Inquire with the seller and/or a licensed professional. Water stains and damage were present in one or more areas. Active water intrusion was noted in one or more areas (dining room/below upper bathroom). A qualified licensed contractor is recommended to evaluate and estimate repairs.

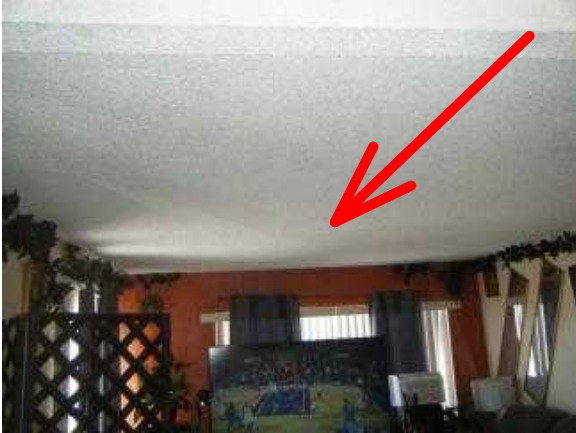
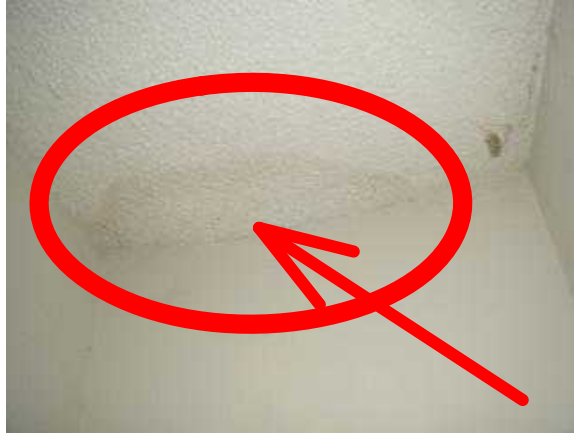
6. **4043 Living Space Ceiling:** Damaged acoustic spray was noted in one or more areas. Testing the acoustic spray is highly recommended to see if it contains asbestos. Cracking noted in the hall. This appears to be where the upper enclosed patio is located. Water stains present. Unable to locate an active leak. Inquire with the seller and/or a licensed professional. Significant signs of sagging were noted to the ceiling (living room/1st bedroom closet). A qualified licensed contractor is recommended to evaluate and estimate repairs.
